**City of Plano, Texas
Russell Creek Interceptor – Odor Evaluation
Summary of Results**

Project No.: Plano 6674; APAI 0718-007-01

Date: February 29, 2016

City of Plano Russell Creek Interceptor Odor Evaluation – Summary of Results

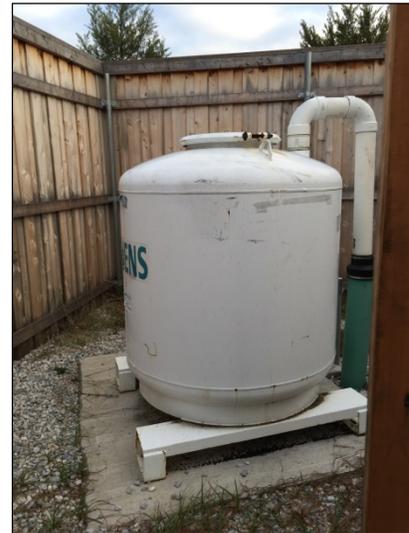
Figure 1: Carbon Canister at Circleview Ct.

The City does not feed any chemicals in the wastewater collection system. NTMWD maintains a chemical feed program to reduce odors and corrosion, but the chemical(s) fed and their dosages are not known. There are two passive carbon-media filters in place along the Russell Creek Interceptor: near manhole (MH) 5294 at the south end of Circleview Ct. (shown in Figure 1), and near MH 5515 at the southwest corner of the Pebble Creek Montessori School parking lot. The carbon filters treat odorous air that is released from their connections to the interceptor. They hold approximately 500 pounds of carbon media each, lasting an average of nine months before the media needs to be replaced, according to City personnel. The City also makes an effort to keep its manholes sealed to reduce the tendency for odors to be released.

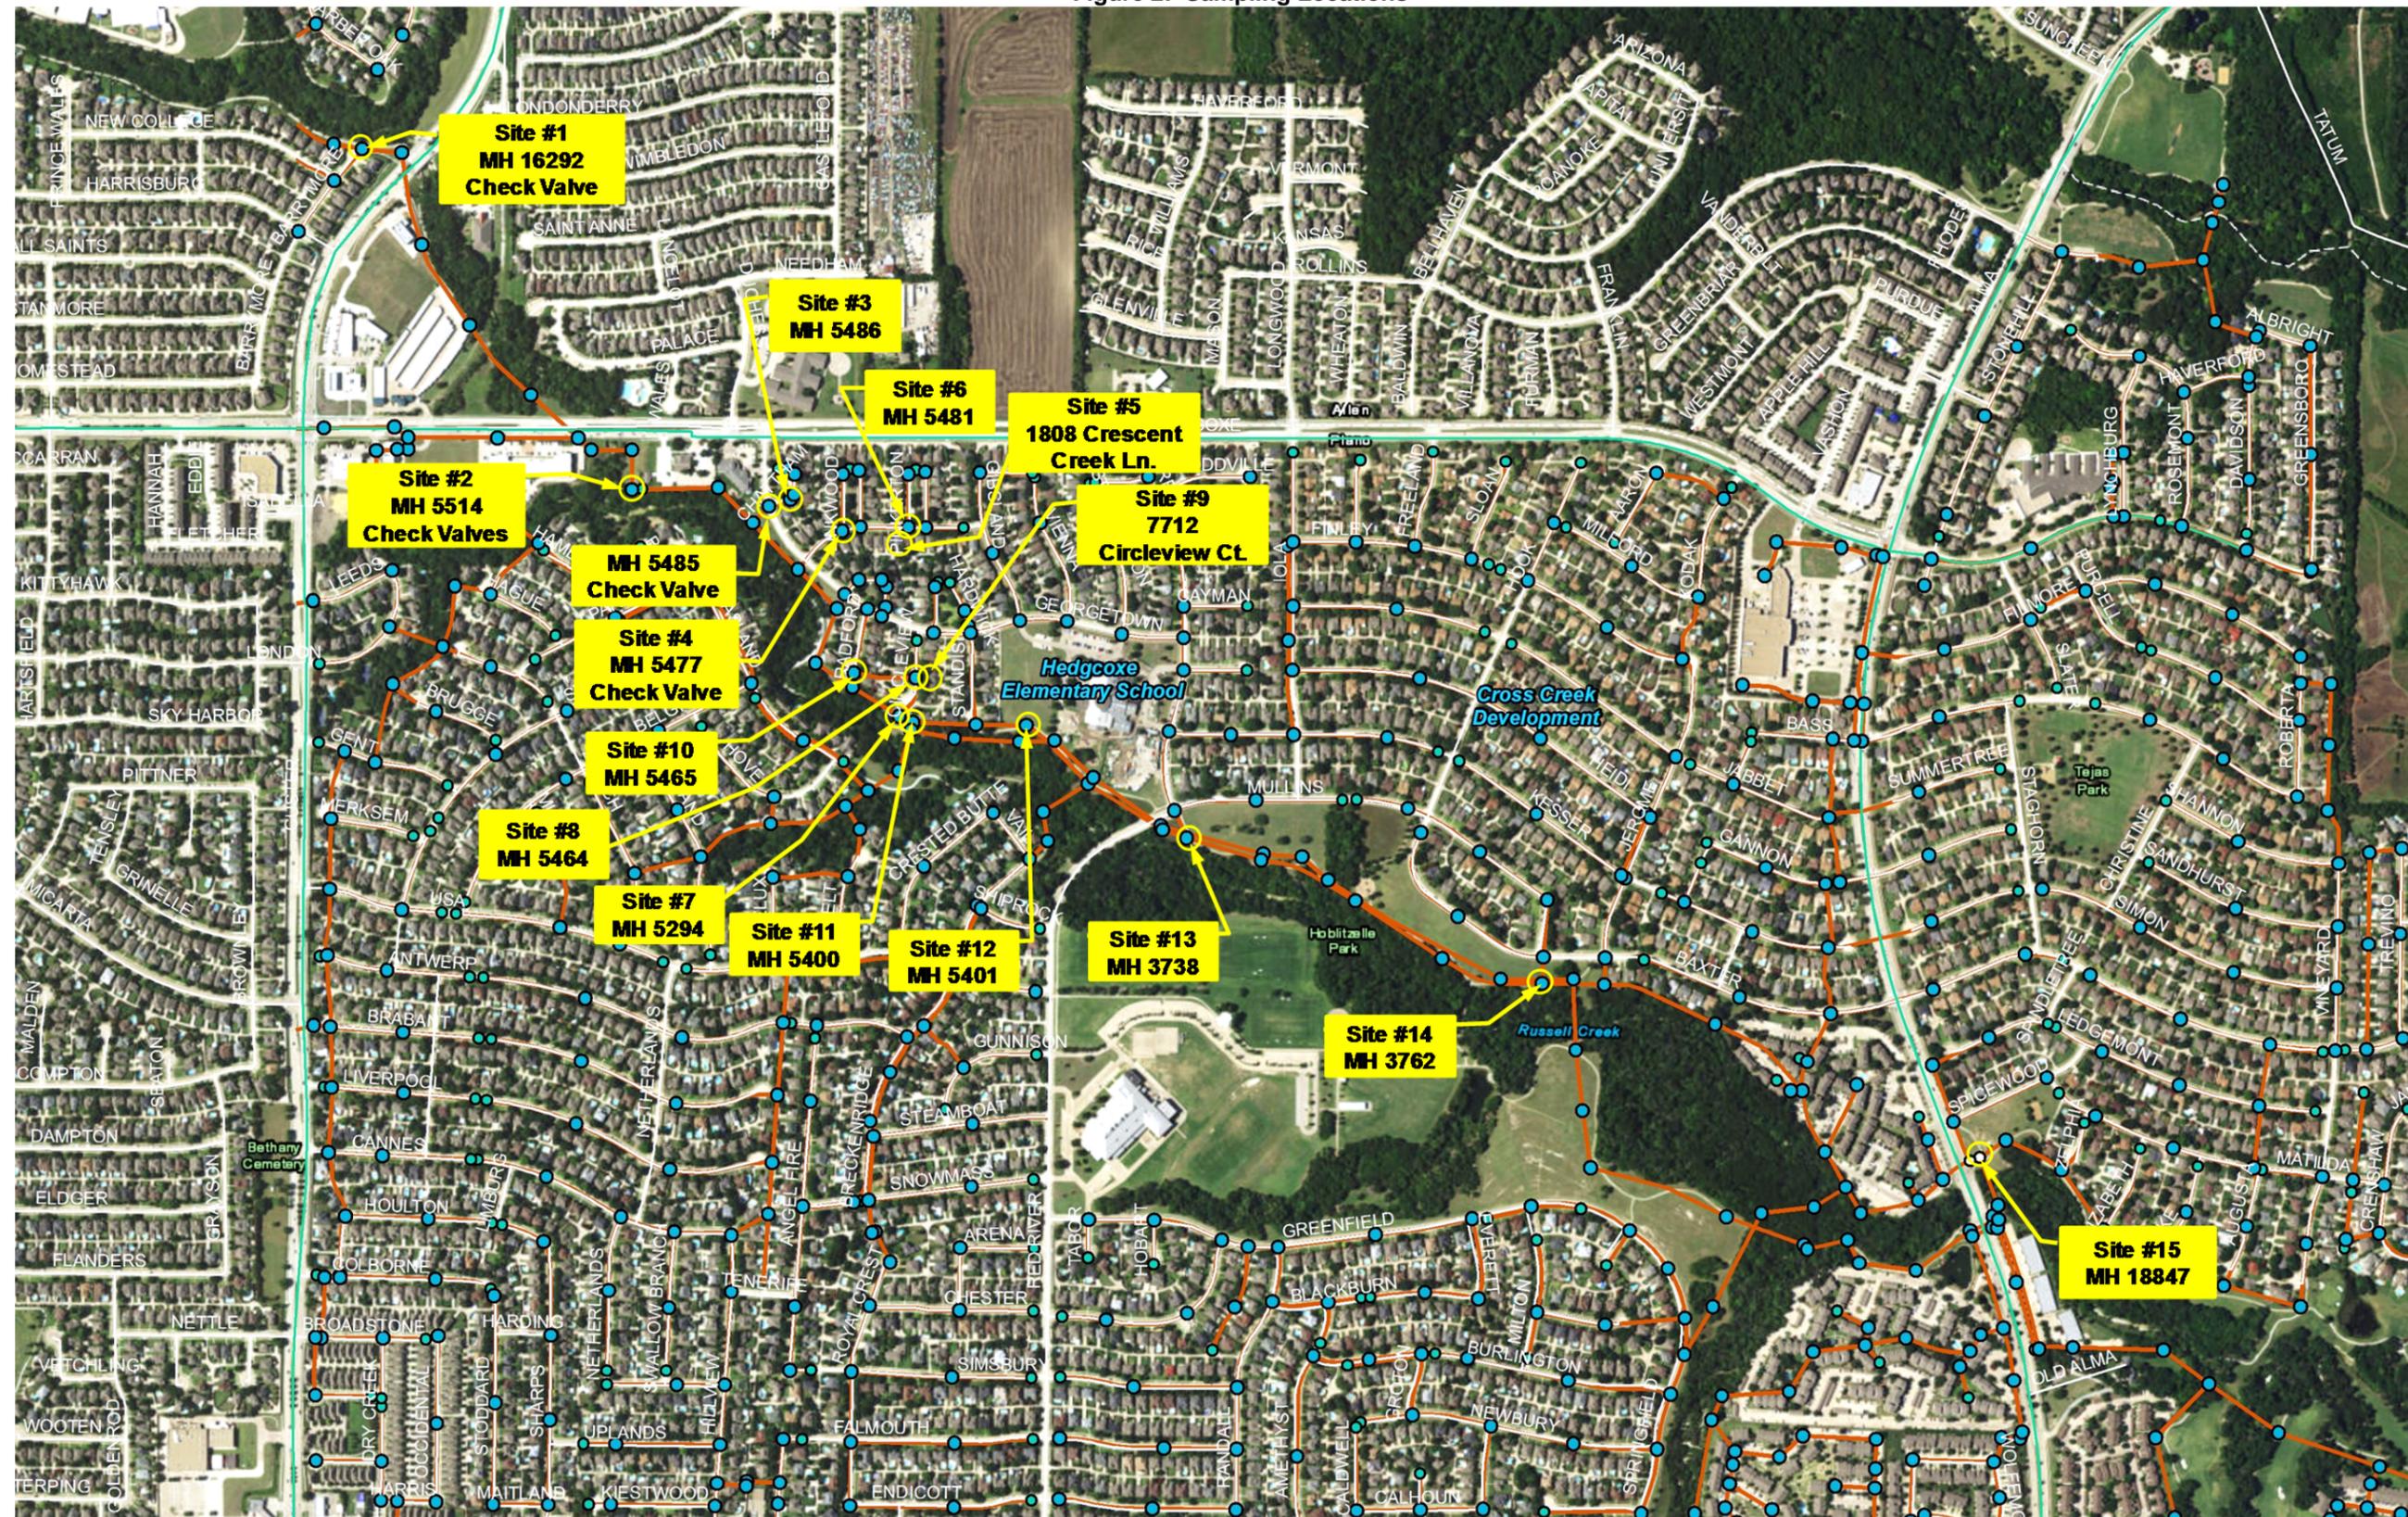
Figure 2: Sampling Locations

Table 3 lists the sampling locations and the dates of when the Odalogs were in place. Figure 2 shows the sampling locations and the extents of the study area.

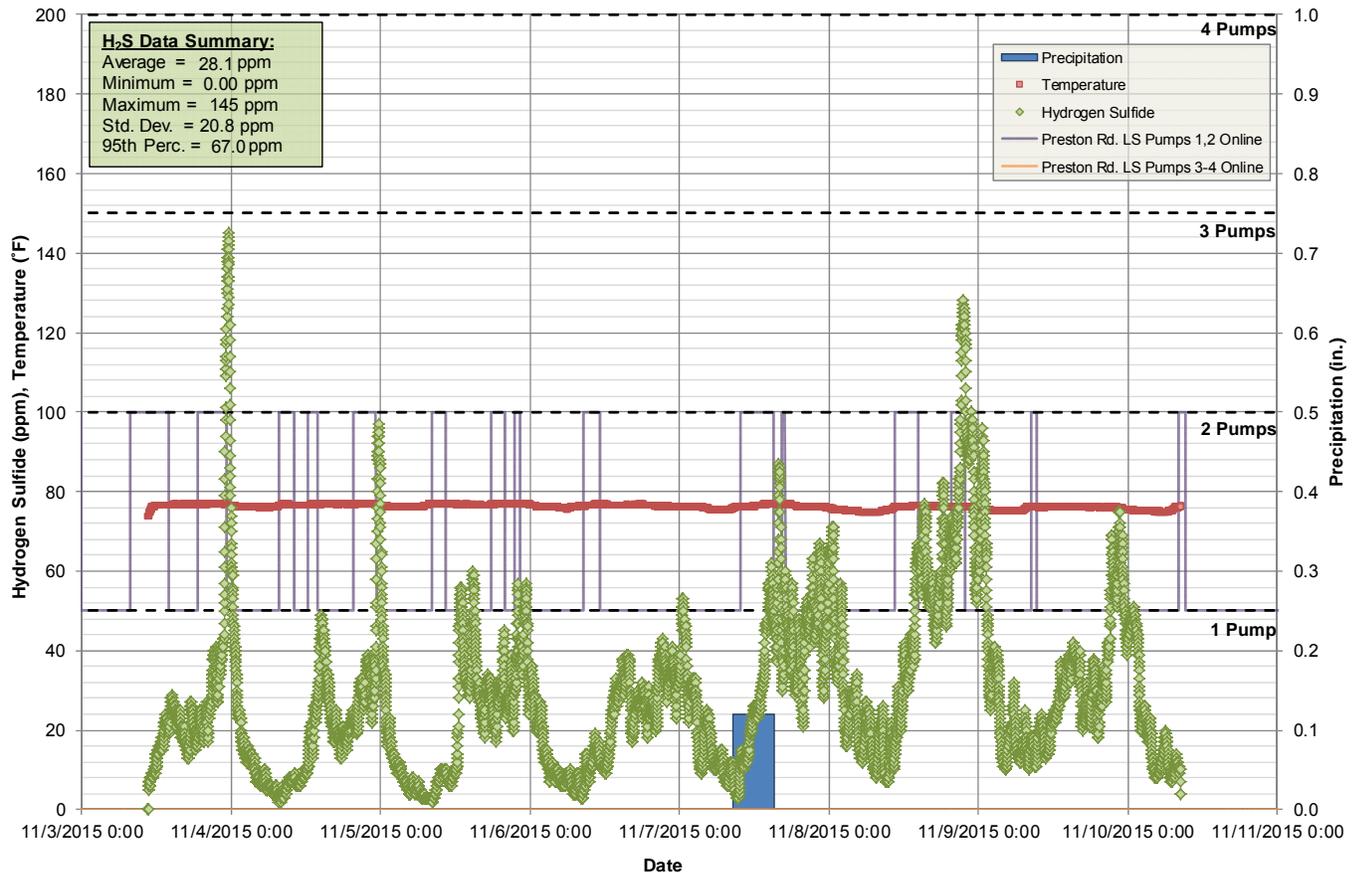
Figure 3: Site #1, MH 16292 Odalog Measurements, Precipitation, and Pump Operation

MH 16292 was selected because it is a tee connection assumed to be prone to turbulence and odor-producing conditions, and was within a reasonable distance upstream to provide a baseline for the conditions entering the study area. MH 16292 is the closest location to the Preston Road Lift Station of the sites sampled. The fluctuations in the Odalog data (Figure 3) appear to correlate with the starting and stopping of a second pump at the lift station. During this period of the testing, only Pumps 1 and 2 were operating.

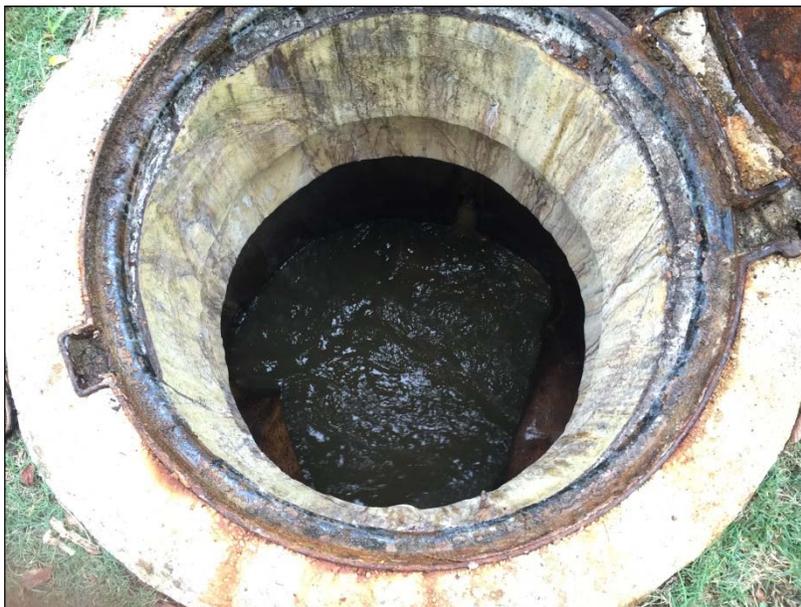
Figure 5: Site #2, MH 5514 Corrosion on Cover

Strong H₂S odors were present each time the manhole was opened. The water surface in the manhole was typically within a foot of the invert of the bottom penetration or higher, with noticeable swirling and turbulence. Corrosion of the manhole cover could potentially be attributed to the release of corrosive odorous gases at this location, as shown in Figure 5. The inlet from the Montessori School was submerged at the time the photo was taken in Figure 6.

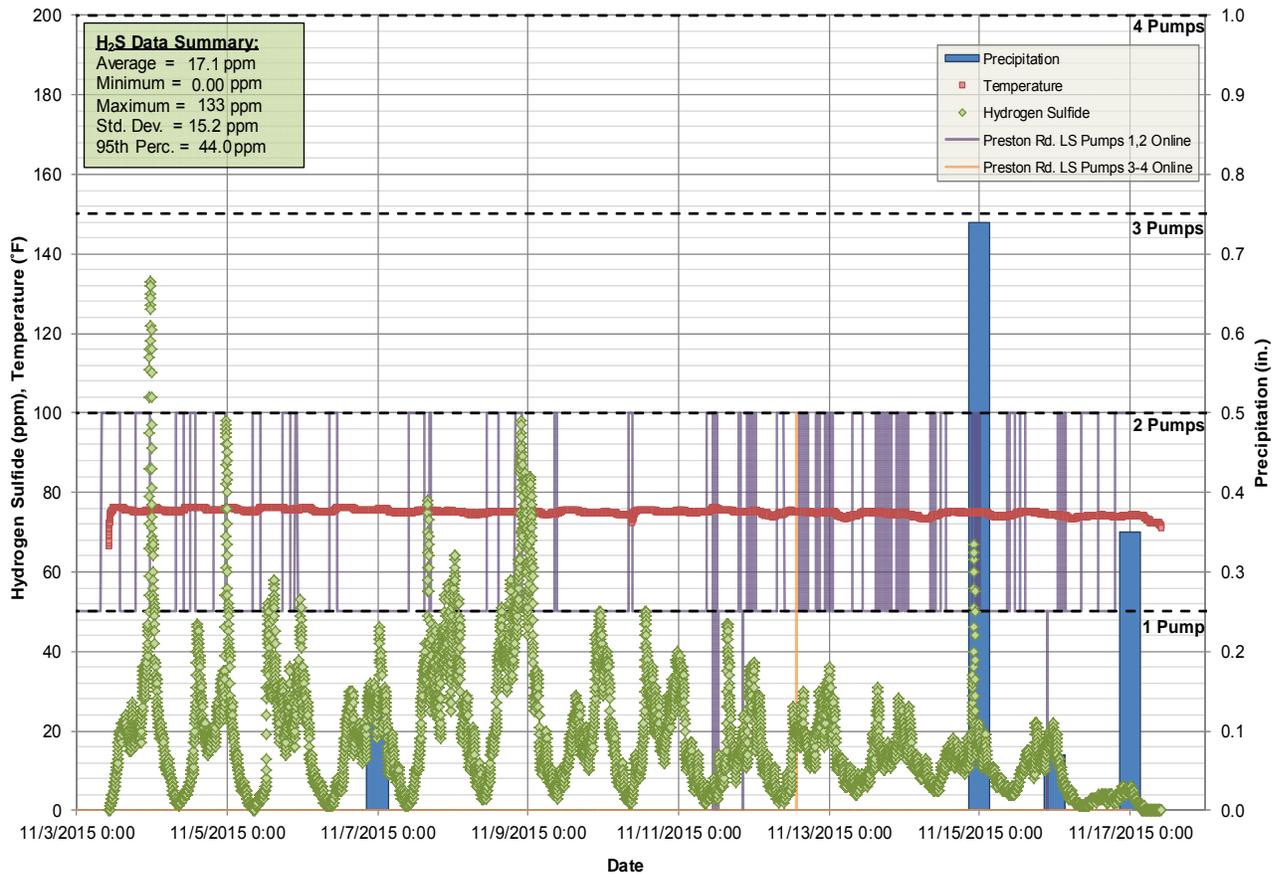
Figure 7: Site #2, MH 5514 Odalog Results, Precipitation, and Pump Operation

A two-week data set was collected for Site #2, as presented in Figure 7. Comparing the results from Site #1 (MH 16292) and Site #2 (MH 5514) from November 3rd through the 10th indicates the foul air is traveling with the wastewater flow as expected. The second week appears to have had more frequent starts and stops of the second online pump at the Preston Road Lift Station. Although the latter part of the data set shows a reduction in the H₂S concentrations that are likely attributed to the rainfall, a noticeable decrease in the concentrations prior to the rain events could also be related to the more frequent pump starts/stops (possibly due to less stagnant conditions in the wet well).

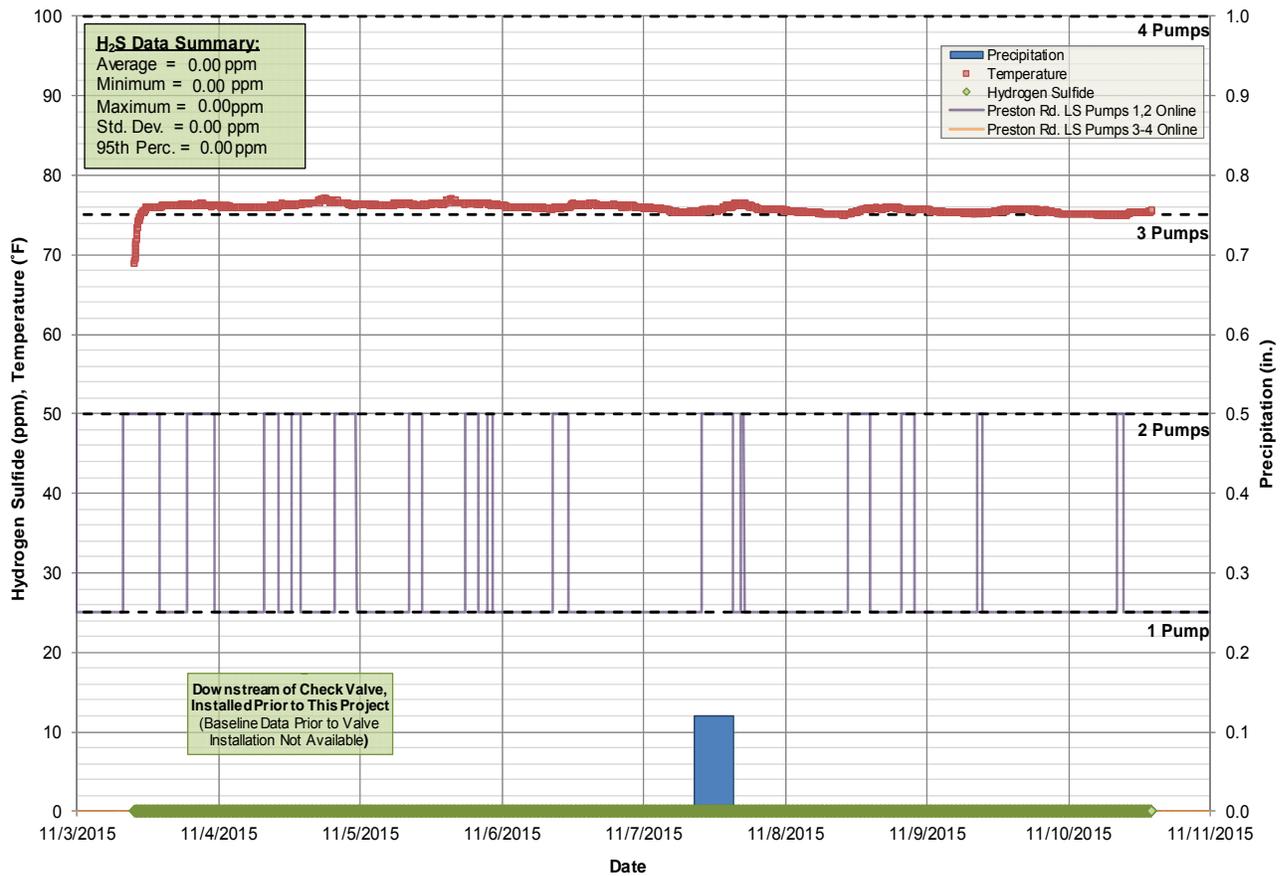
Figure 8: Site #3, MH 5486 Odalog Results, Precipitation, and Pump Operation

This site was selected because of its location relative to the Montessori School and the existing check valve installed in the downstream lateral, near the intersection of Georgetown Dr. and Chattham Ct. Wastewater was not flowing through this manhole at the time of sampling, and the Odalog results confirm that the check valve is preventing foul air from migrating into this segment, as shown in Figure 8.

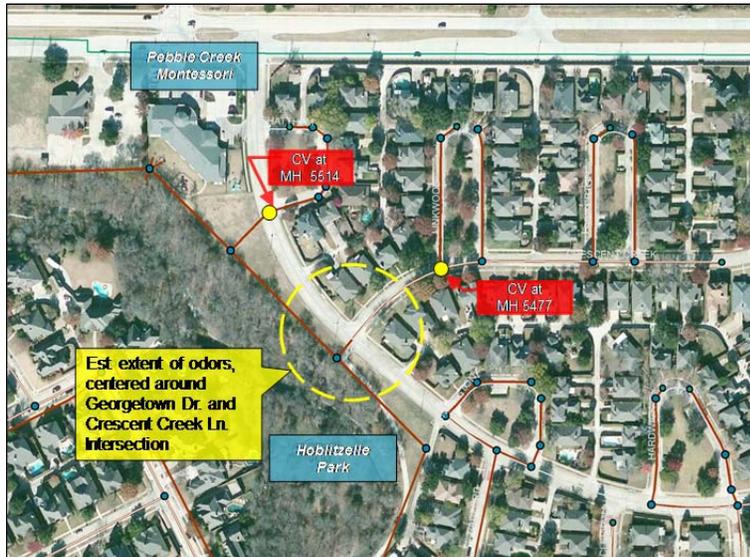
Figure 9: Location of Odors Near Georgetown Dr. & Crescent Creek Ln.

Odors were observed on November 10th at the intersection of Georgetown Dr. and Crescent Creek Ln., when a faint breeze was coming from the south. This intersection is the midpoint along the Russell Creek Interceptor, where each of the two nearest upstream residential laterals have check valves installed, illustrated in Figure 9.

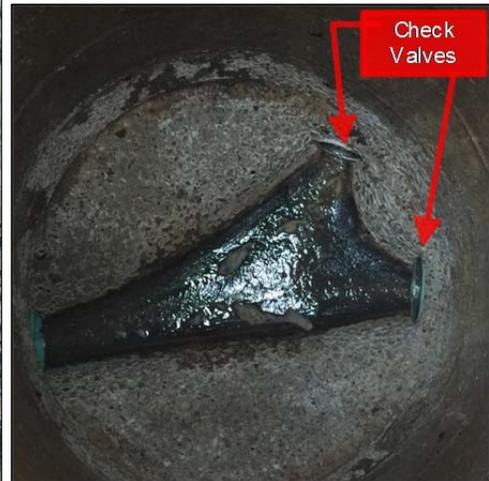
Figure 10: Site #4, MH 5477 Looking North

This location was selected because of the check valves that were installed on October 29th. During the check valve installation (around 2:00pm), strong ambient H₂S odors were observed by City personnel. Odors were also noted in several instances by residents and APAI during the study period, particularly around the addresses of 1800 to 1808 Crescent Creek Ln. Odors seemed to linger between the adjacent homes along the south side of the street (or back alley area). It’s unknown whether or not odors have increased with the installation of the check valves at this location.

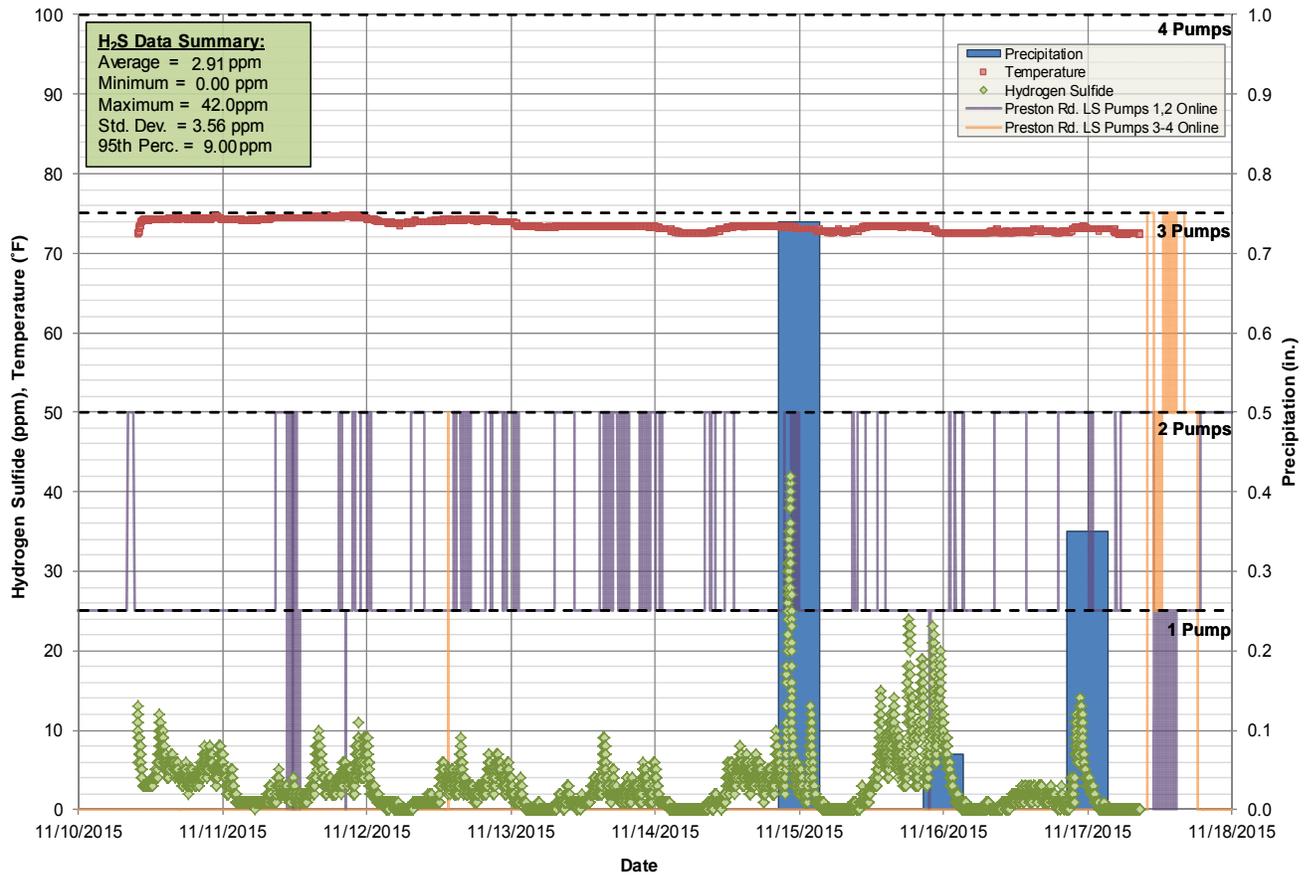
Figure 11: Site #4, MH 5477 Odalog Results, Precipitation, and Pump Operation

Similar to MH 5514 (behind Pebble Creek Montessori School) at times where there are more frequent starts/ stops of the Preston Road Lift Station pumps, there’s a noticeable decrease in the overall H₂S concentrations. The Odalog results for this location are shown in Figure 11.

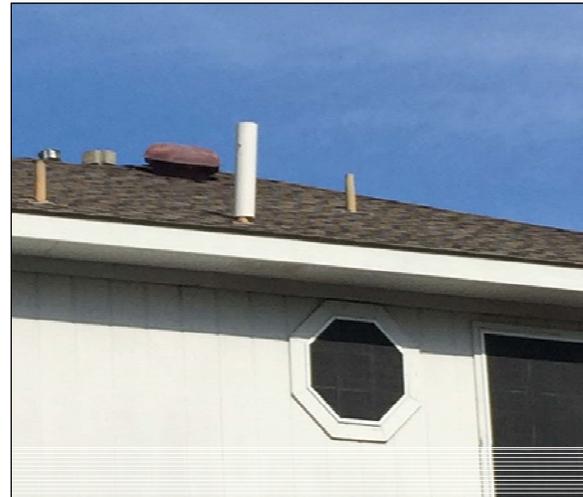
Figure 12: Odalog Inside PVC Pipe on Site #5 1808 Crescent Creek Ln. 2nd Story Bathroom Vent

The homeowner at 1808 Crescent Creek Ln. allowed the placement of an Odalog on the vent stack of the upstairs bathroom, near the back of the home. Because gaseous H₂S is heavier than air, the Odalog results from the second floor vent were expected to be on a lesser scale than if it were placed on a one-story vent. The homeowner indicated that odors are common in that area and are also sometimes a nuisance inside their home, namely the upstairs bathroom.

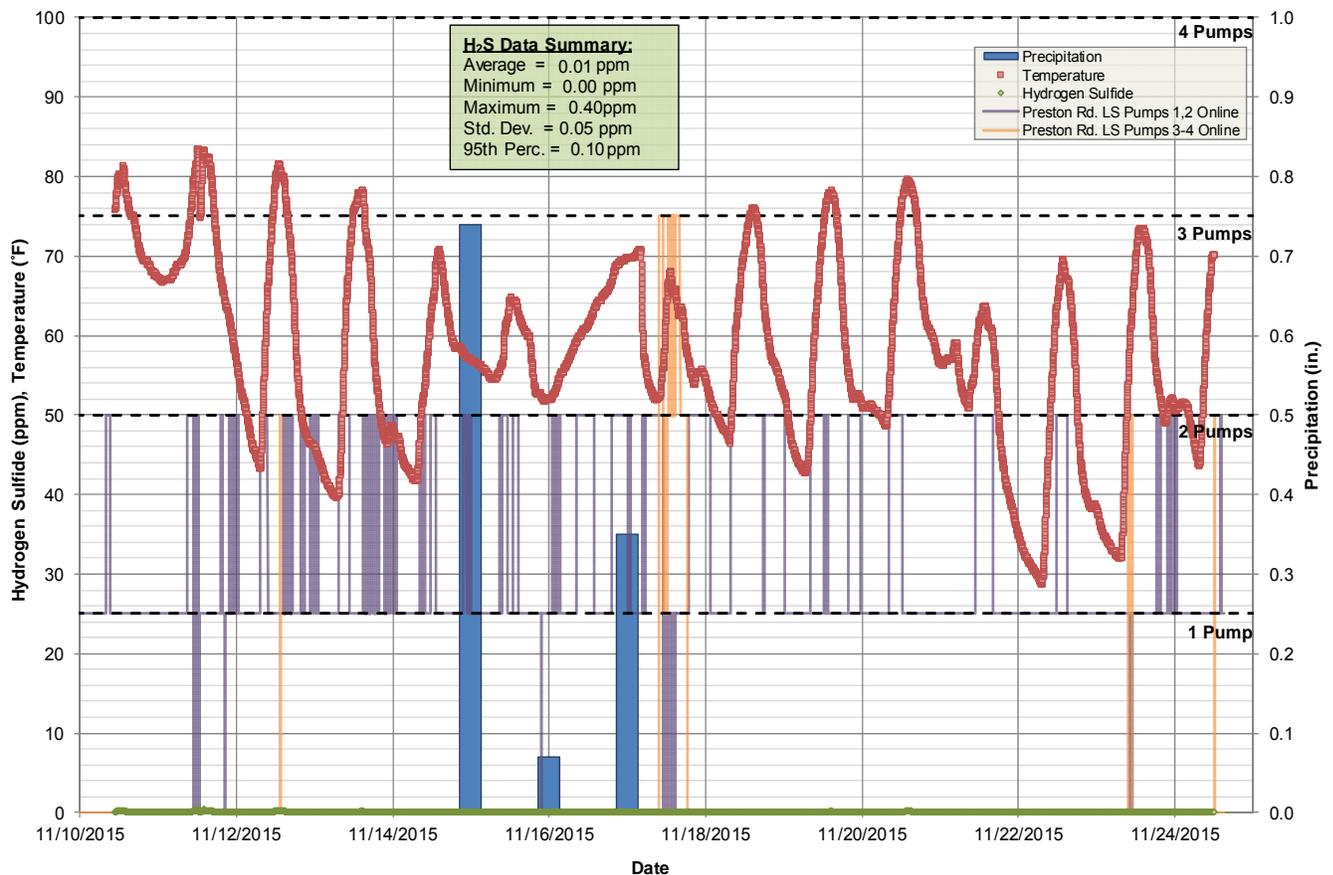
Figure 13: Site #5, Crescent Creek Ln. Roof Vent Odalog Results, Precipitation, and Pump Operation

Although the odors measured at the roof vent are very low at 0.40 ppm (Figure 13), the readings were more than eight times the human perception range despite the longer path taken out of the second-story vent. It can be assumed that the adjacent one-story homes are capable of releasing odors with significantly higher concentrations, which could be responsible for the foul odors in this immediate area.

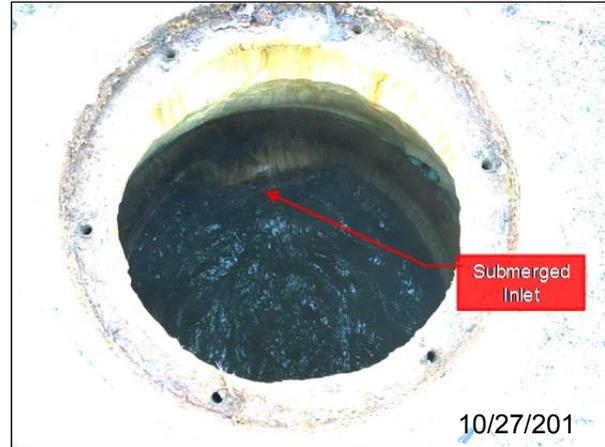
Figure 15: Site #7 MH 5294 Looking Northwest

This location was selected as one of the first sampling locations, because it is in the immediate vicinity of one of the carbon canisters and is a location from where several odor complaints have originated over the last several years. On the first day of sampling on October 27th, flows were moderate to low when the manhole was first opened around 8:10 am. Shortly thereafter, the flows increased and the inlet to the manhole from the interceptor became submerged. The increased flow volume is related to an additional pump starting up at the Preston Road Lift Station at 8:17am, according to the Preston Road Lift Station operational data. Figure 15 shows the conditions inside the manhole at 8:42 am. Turbulence and countercurrents because of the submerged outlet are visible.

Under normal flow conditions, the headspace in gravity segments of a pipeline will pull the air along with the flow. When the inlets/outlets of the interconnecting manholes become submerged, there is nowhere for the air to go within the system and odors are forced out through any openings or vents. Reducing the flow through the system to prevent surcharging in the manholes will likely reduce the release of odors, though it will not eliminate them.

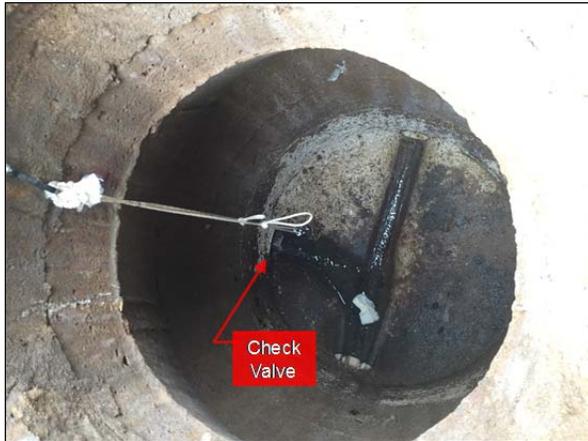
Figure 17: Site #8, MH 5464 Looking North-Northwest on November 10th

On November 4th, a check valve was installed in this manhole to reduce odors flowing into the lateral from Radford Circle to the west. Figure 17 shows the check valve in MH 5464.

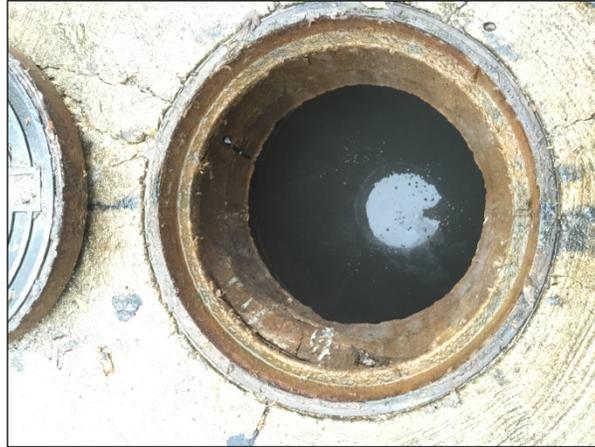
Figure 19: Site #8, MH 5264 Looking Northwest on November 17th

When the Odalog was retrieved from MH 5264, the unit was partially submerged. The wastewater was not flowing, and was not sampled. It was assumed that the stagnant condition at this location was due to the downstream MH 5294 being surcharged, though this assumption was not confirmed. A significant rainfall event occurred over the last three days of the monitoring period of this site. Figure 19 shows the standing water inside MH 5264.

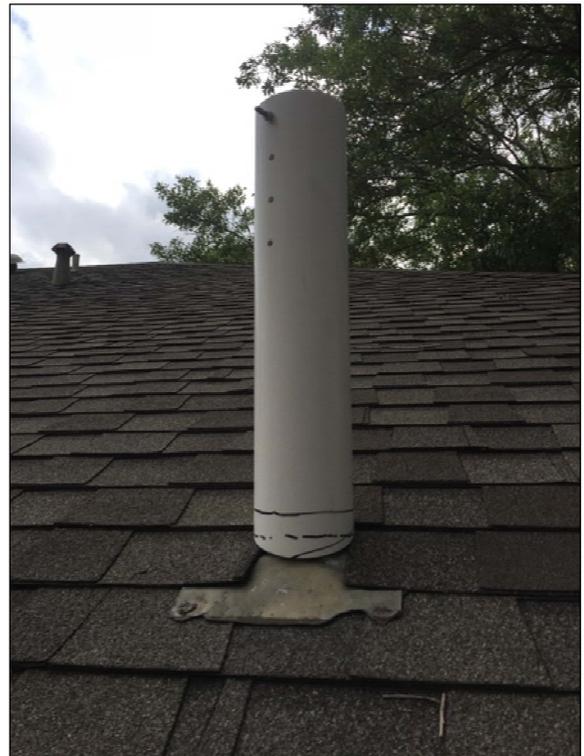
Figure 20: Site #9, Odalog Inside PVC Pipe on 7712 Circleview Ct. NE Rooftop Vent

Because of the observations previously discussed in Paragraph 4.8, the homeowner was approached for permission to place an Odalog on their roof (Figure 20).

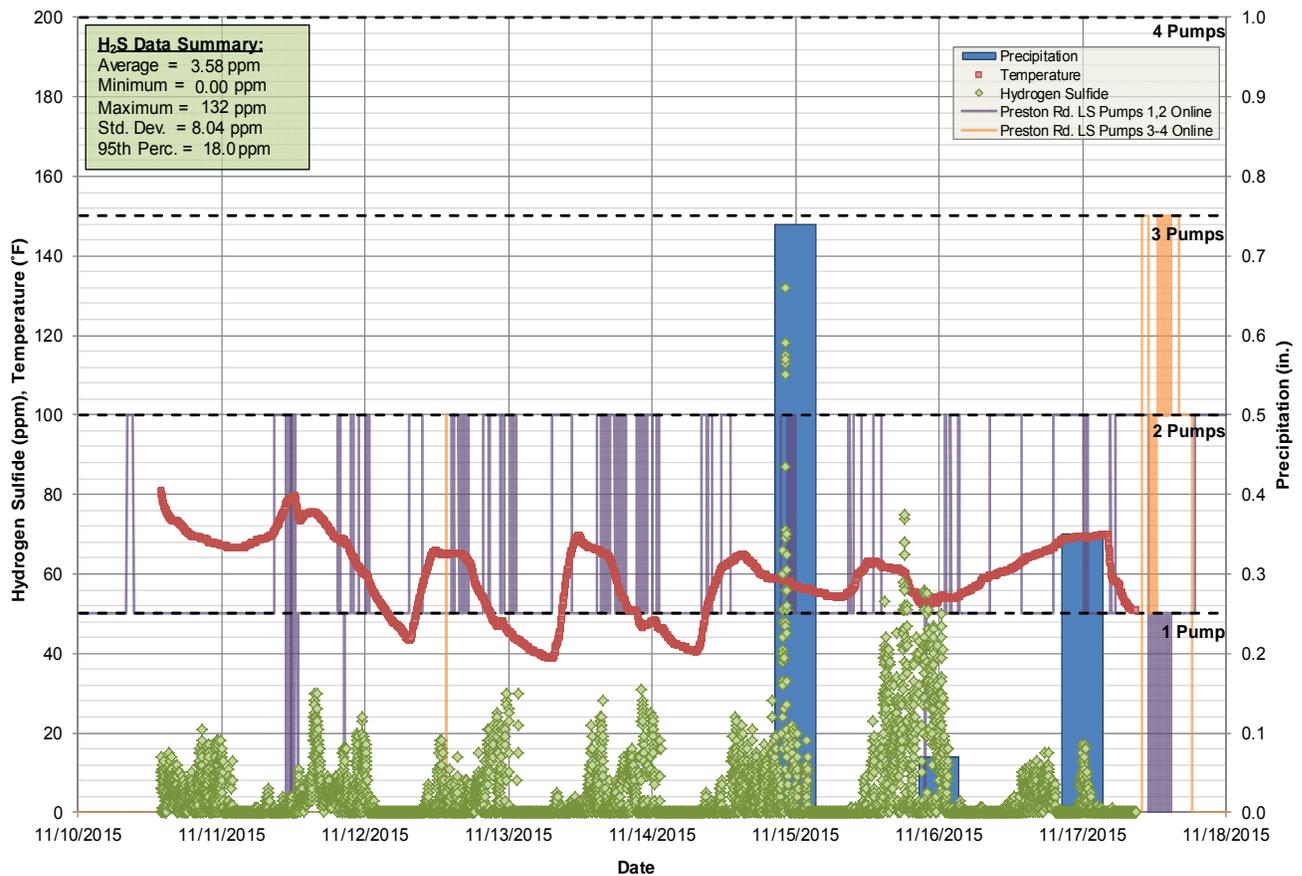
Figure 21: Site #9, Circleview Ct. Roof Vent Odalog Results, Precipitation, and Pump Operation

The fluctuations in the H₂S concentrations measured at this location are similar to those measured at MH 5464, directly downstream. Because of these similarities, it can be assumed that the foul air that does not migrate further upstream toward the segment terminating at the north end of Circleview Ct. is released in the vents in the immediate vicinity. On several occasions, odors were observed along the length of Circleview Ct.

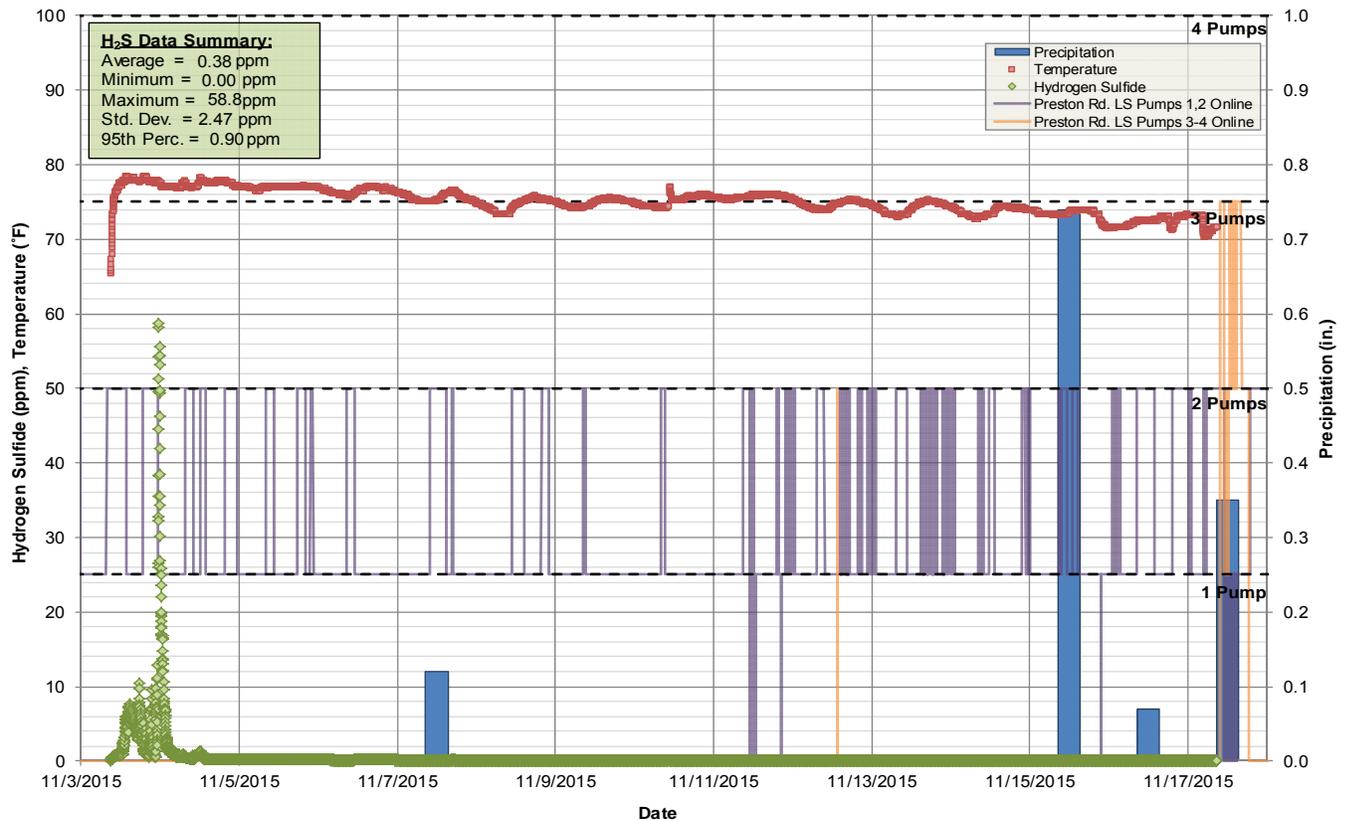
Figure 22: Site #10, MH 5465 Odalog Results, Precipitation, and Pump Operation

On the afternoon of November 3rd, odors were observed coming from the entrance of Radford Circle or from between the houses at the corner, but not the manholes in the street. Residents also indicated prior to sampling beginning that odors seem to come from between the homes and are worse when the wind is from the south or southeast. Residents’ observations after the installation of the check valve at MH 5264 (midpoint of Circleview Ct.) were not available at the time this memorandum was prepared.

The check valve in the upstream MH 5264 (midpoint of Circleview Ct.) appears to have a significant effect on preventing the odors from flowing into this location at MH 5465. Another Odalog in the immediate vicinity was not available for the same time period of the spike on November 3rd, before the check valve was installed. However, the Odalog results at MH 5514 (behind Pebble Creek Montessori School) show a spike at the same time in the range of 145 ppm.

The turbulence observed upstream of the Radford Circle and Circleview Ct. laterals, primarily at the south end of Circleview Ct. (MH 5294) and in the downstream manhole in the front yard of 7700 Circleview Ct. (MH 5400), may be responsible.

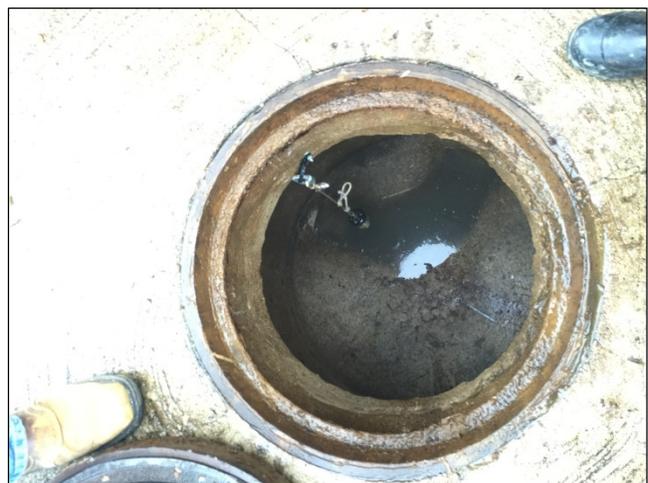
Figure 23: Site #10, MH 5465 on November 17th

At the time when the Odalog was retrieved, there was standing water in the recessed area of the manhole floor, assumed to be related to the submerged conditions noted in Paragraph 4.8.

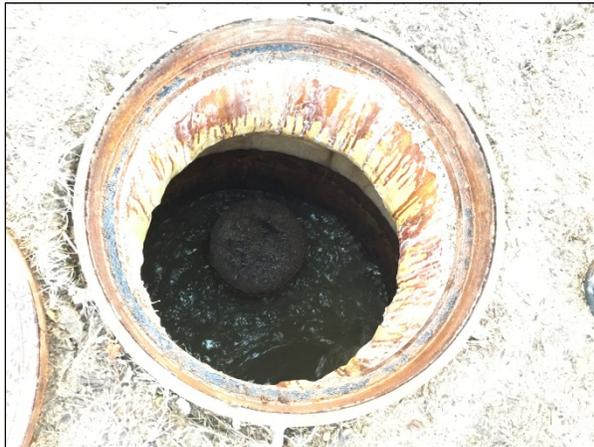
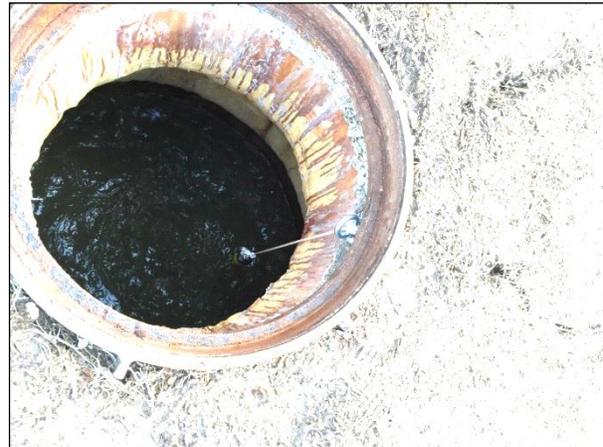
Figure 24: Site #11, MH 5400 at 8:21 am Figure 25: Site #11, MH 5400 at 9:20 am

The conditions at MH 5400 were very similar to those observed at MH 5492 at the south end of Circlevue Ct. Figures 24 and 25 show the difference in the water surface before and after the increase in flow, with the photos taken at 8:21 am and 9:20 am, respectively. According to the City, the object in the middle of MH 5400 is part of the plug installed when the segment from MH 5400 to MH 5295 was plugged.

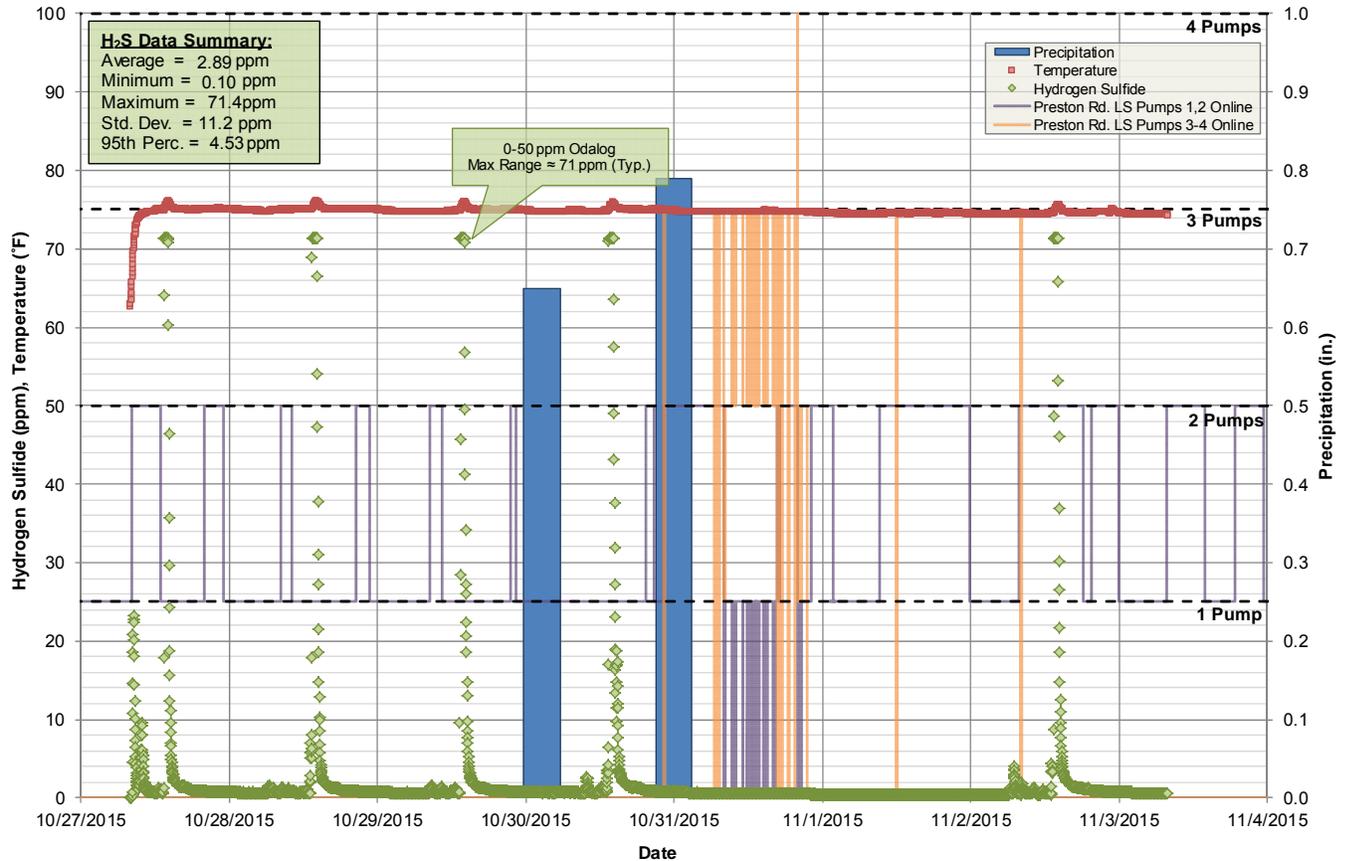
Figure 27: Site #12, MH 5401 Odalog Results, Precipitation, and Pump Operation

This location was selected because of historical odor complaints in the vicinity, where it has been the assumed culprit, as it is located directly alongside the walk path from Hoblitzelle Park. It is also the endpoint of the plugged segment stretching from MH 5400 (front yard at 7700 Circleview Ct.). Since the upstream plug has been installed, this manhole only receives flow from the upstream residential laterals and Hedgcoxe Elementary school.

Overall, the H₂S concentrations at this site are relatively low; however, spikes as high as 71 ppm were measured. It's not obvious whether or not these spikes in H₂S are related to the pump station operation. The odor spikes occur between 1:00 pm and 2:30 pm on weekdays, suggesting that the odors may be as a result of the cleanup activities from the lunchroom. When the grease trap is disturbed after sitting dormant overnight, significant odors can be produced.

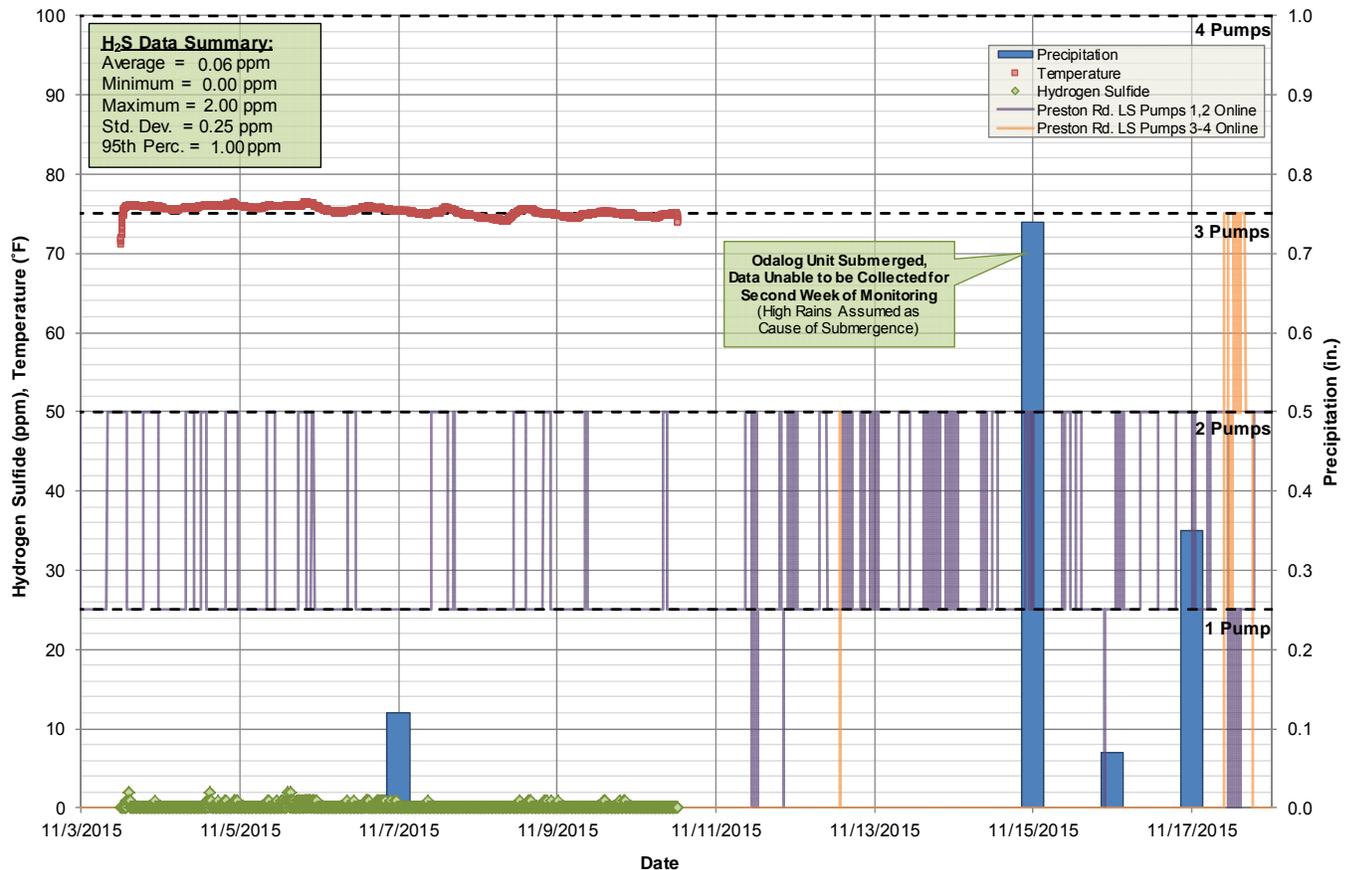
Figure 28: Site #13, MH 3738 Odalog Results, Precipitation, and Pump Operation

This site was chosen to determine if the conditions immediately downstream of the area of interest near Circleview Ct. were similar to the areas upstream, and because residents had noted odors in this area. This location is deeper than those upstream, and moderate H₂S odors were observed when the manhole was opened.

The H₂S odors in this location are significantly less than upstream, indicating that a majority of the odors may be released upstream prior to the plug at MH 5400, where flows split into two segments before recombining downstream of the study area. It's not clear on Figure 1, but Figure 29 shows how when the plug was installed between MH 5400 and MH 5295, it isolated flows into only the 27-inch segment before reconnecting at the junction box at MH 15027. At the time the sampling locations were selected, the configuration of the parallel pipelines and their downstream connection location was not known.

A significant rainfall event occurred during the second week of sampling in this location. When the Odalog was retrieved, it had been submerged and the data was lost for the latter duration.
