**City of Plano, Texas
Russell Creek Interceptor – Odor Evaluation
Summary of Results**

Project No.: Plano 6674; APAI 0718-007-01

Date: February 29, 2016

City of Plano Russell Creek Interceptor Odor Evaluation – Summary of Results

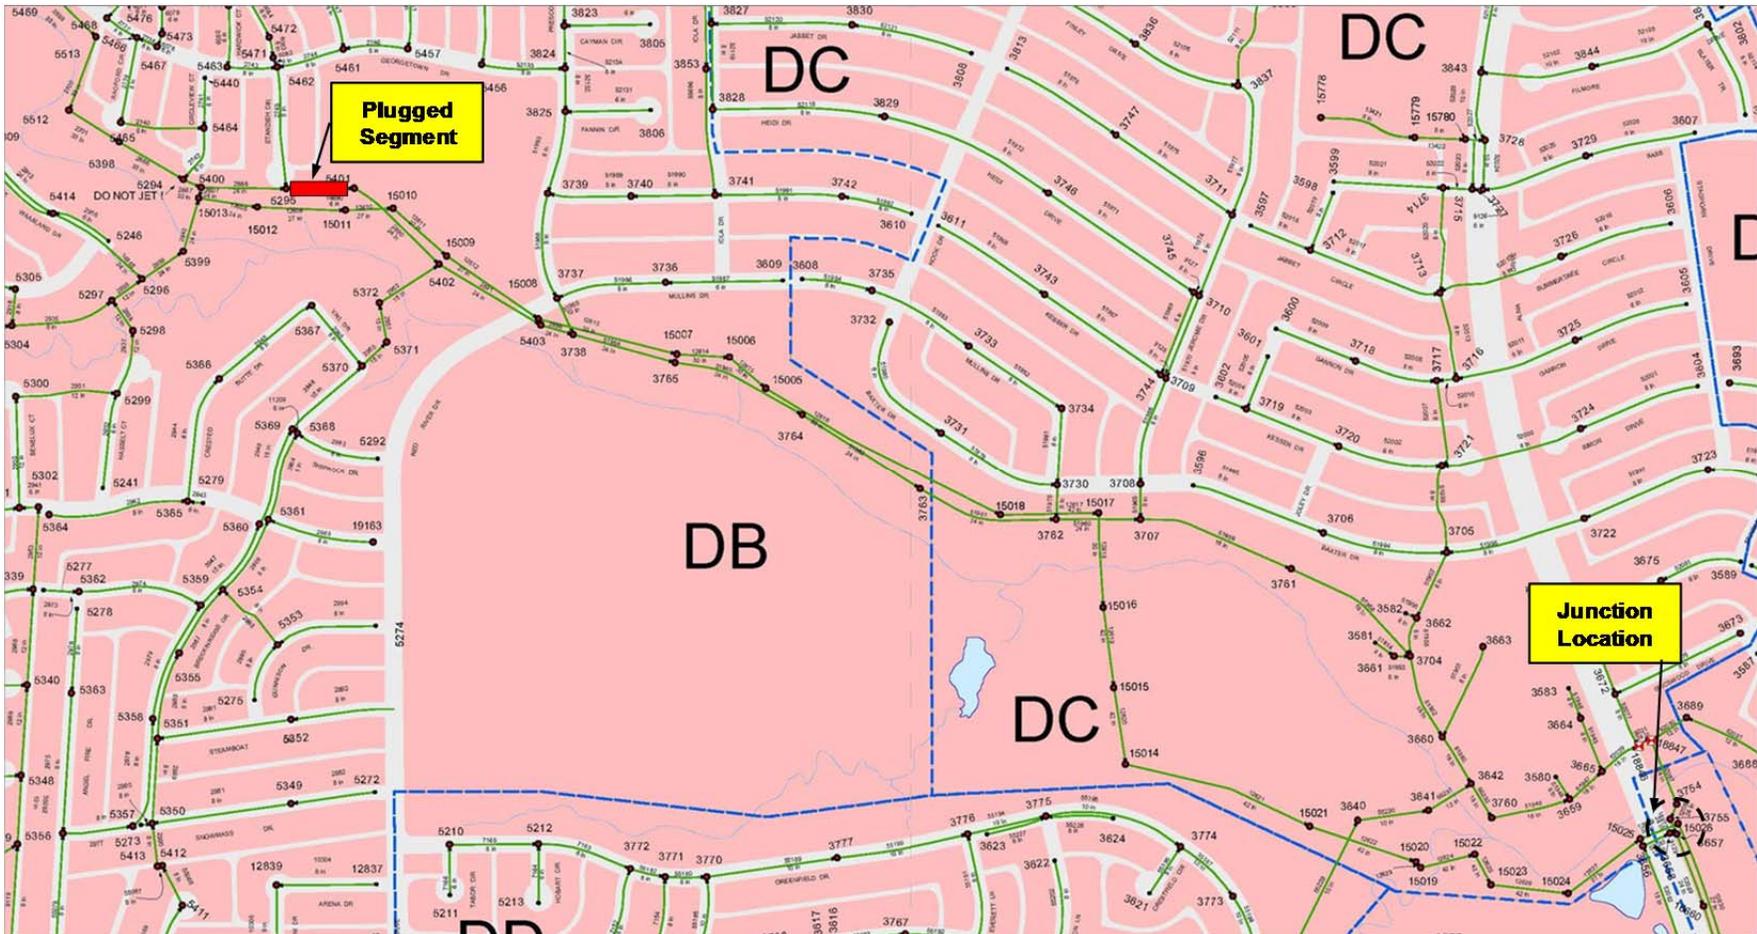
Figure 29: Parallel Russell Creek Interceptor Segments From MH 5401 to MH 15026

The H₂S odors in this location are significantly less than upstream, indicating that a majority of the odors may be released upstream prior to the plug at MH 5400, where flows split into two segments before recombining downstream of the study area. It's not clear on Figure 1, but Figure 29 shows how when the plug was installed between MH 5400 and MH 5295, it isolated flows into only the 27-inch segment before reconnecting at the junction box at MH 15027. At the time the sampling locations were selected, the configuration of the parallel pipelines and their downstream connection location was not known.

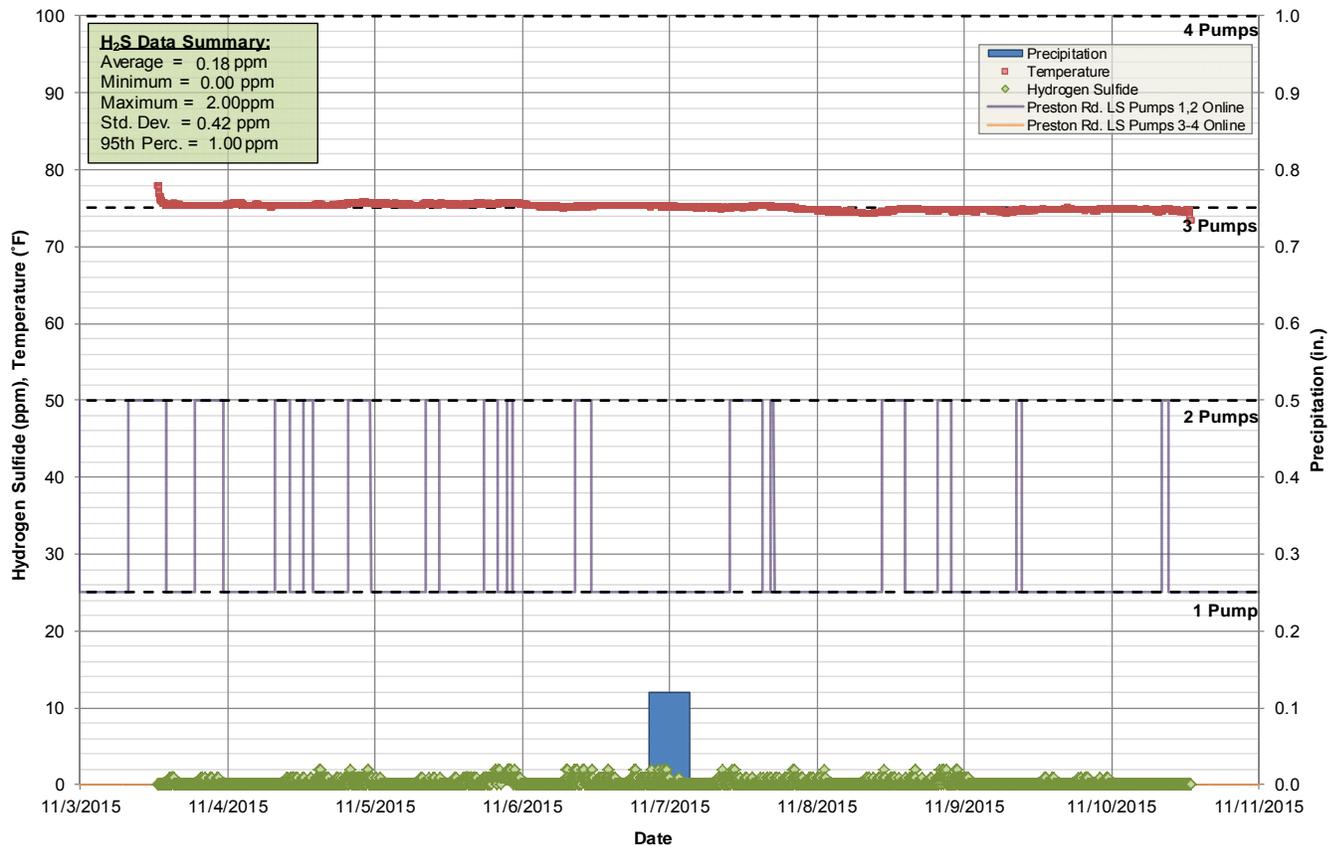
Figure 30: Site #14, MH 3762 Odalog Results, Precipitation, and Pump Operation

This site is similar to the conditions at MH 3738 (at Preston and Mullins), but is several feet deeper and nearer to Russell Creek. It's assumed that the flow velocities could be higher because of the greater depth and higher associated slopes. In addition, the deeper manholes leave more space for foul air to stay beneath the manhole lid, rather than be released.

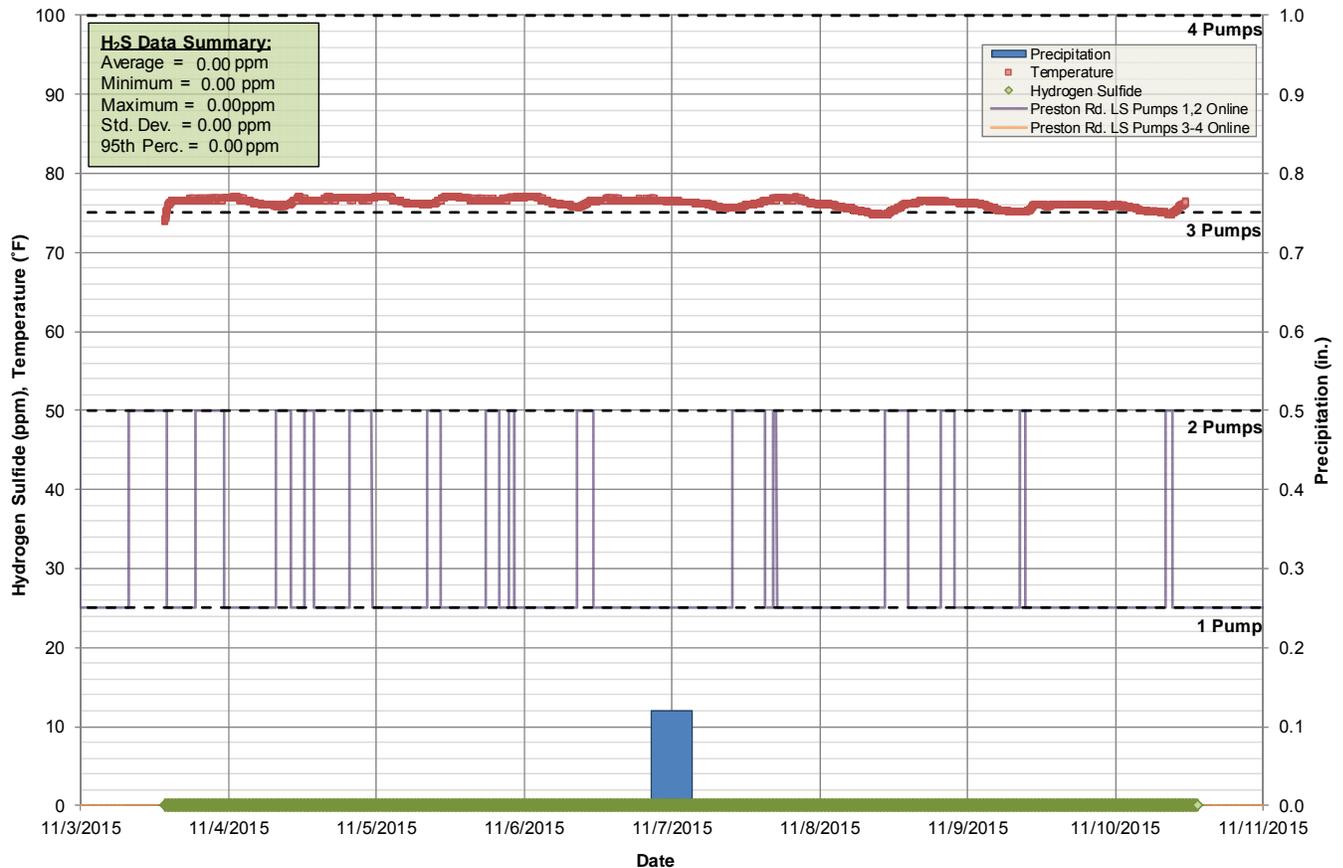
Figure 31: Site #15, MH 18847 Odolog Results, Precipitation, and Pump Operation

This location was selected, because it is on the further limits of the study area. Manholes slightly further upstream from this location were considered as alternative sampling locations, but they could not be easily accessed due to their location, or were too deep to be considered a likely odor source. This location was ultimately selected to provide a downstream baseline and because odor complaints had been received in its general area 2-3 weeks prior to the start of sampling. The junction where the two segments shown in Figure 29 connect is likely the cause of odors previously mentioned in this area.

Odors were not significant during sampling in this location. The Odalog results in Figure 31 also indicate that odors may not be a concern in this location. It should be noted that this manhole was several feet deeper than the others upstream and the high water mark for this manhole was several feet higher than the other sampling locations. As such, the Odalog could not be hung very deep and would be several

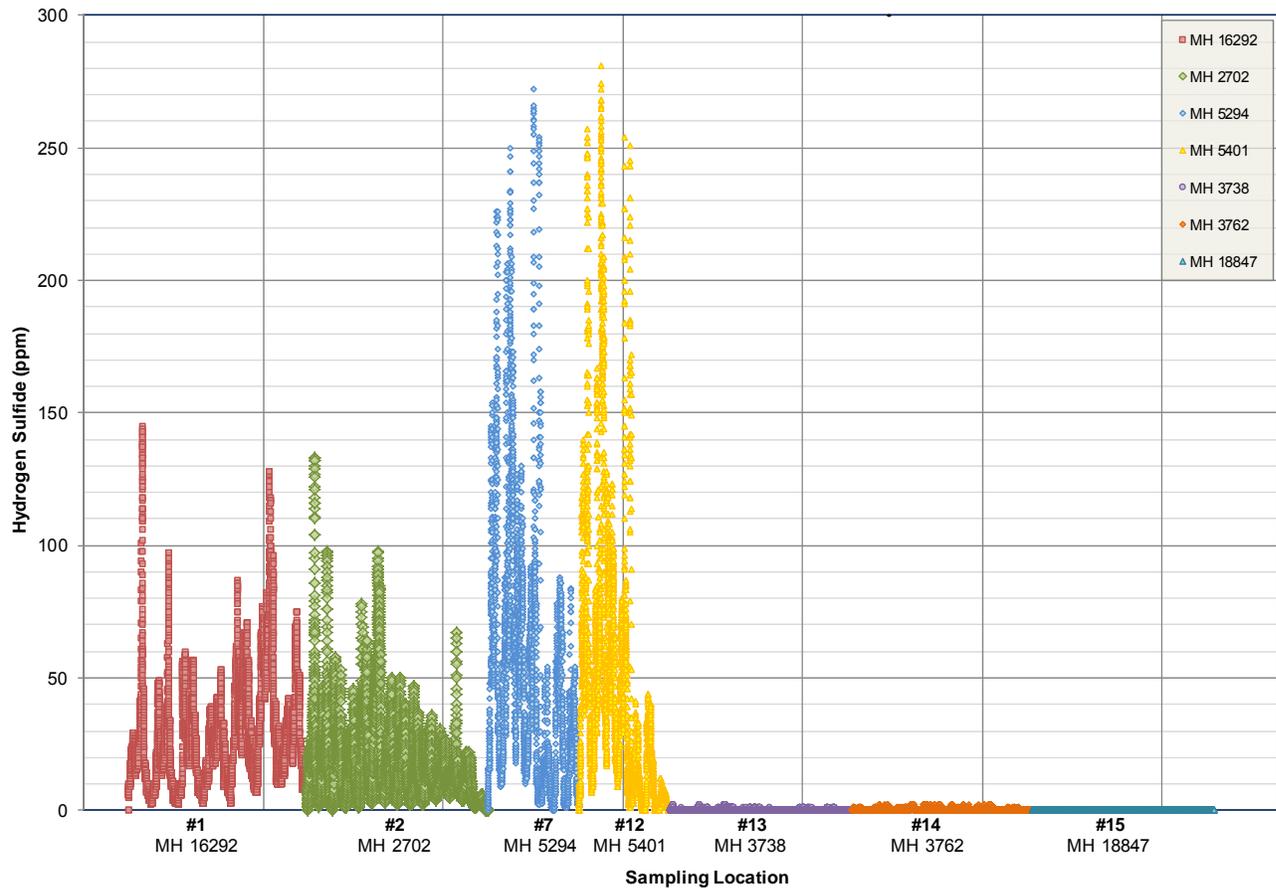
Figure 32: Combined Consecutive Odalog Results Along Russell Creek Interceptor

Assuming the results for each individual site are demonstrative of typical conditions, it's clear that the turbulence that occurs at the interconnections near MH 5294 and MH 5400 may be where the odors are being produced and released. The parallel segment from MH 5401 (shown in Figure 29) does not carry wastewater from the Russell Creek Interceptor main line, so the reduced wastewater age does not have the same odor-producing potential.
